Rip-Rap Repair, Structure Maintenance, and Creation of Fish Habitat in Pass (Norns) Creek 2015 - 2016

FWCP # F-F16-25 & F-F15-25

March 2016

Evan Smith, BSc
Okanagan Nation Alliance
L2 - 1444 Columbia Ave.
Castlegar, BC, V1N 3K3

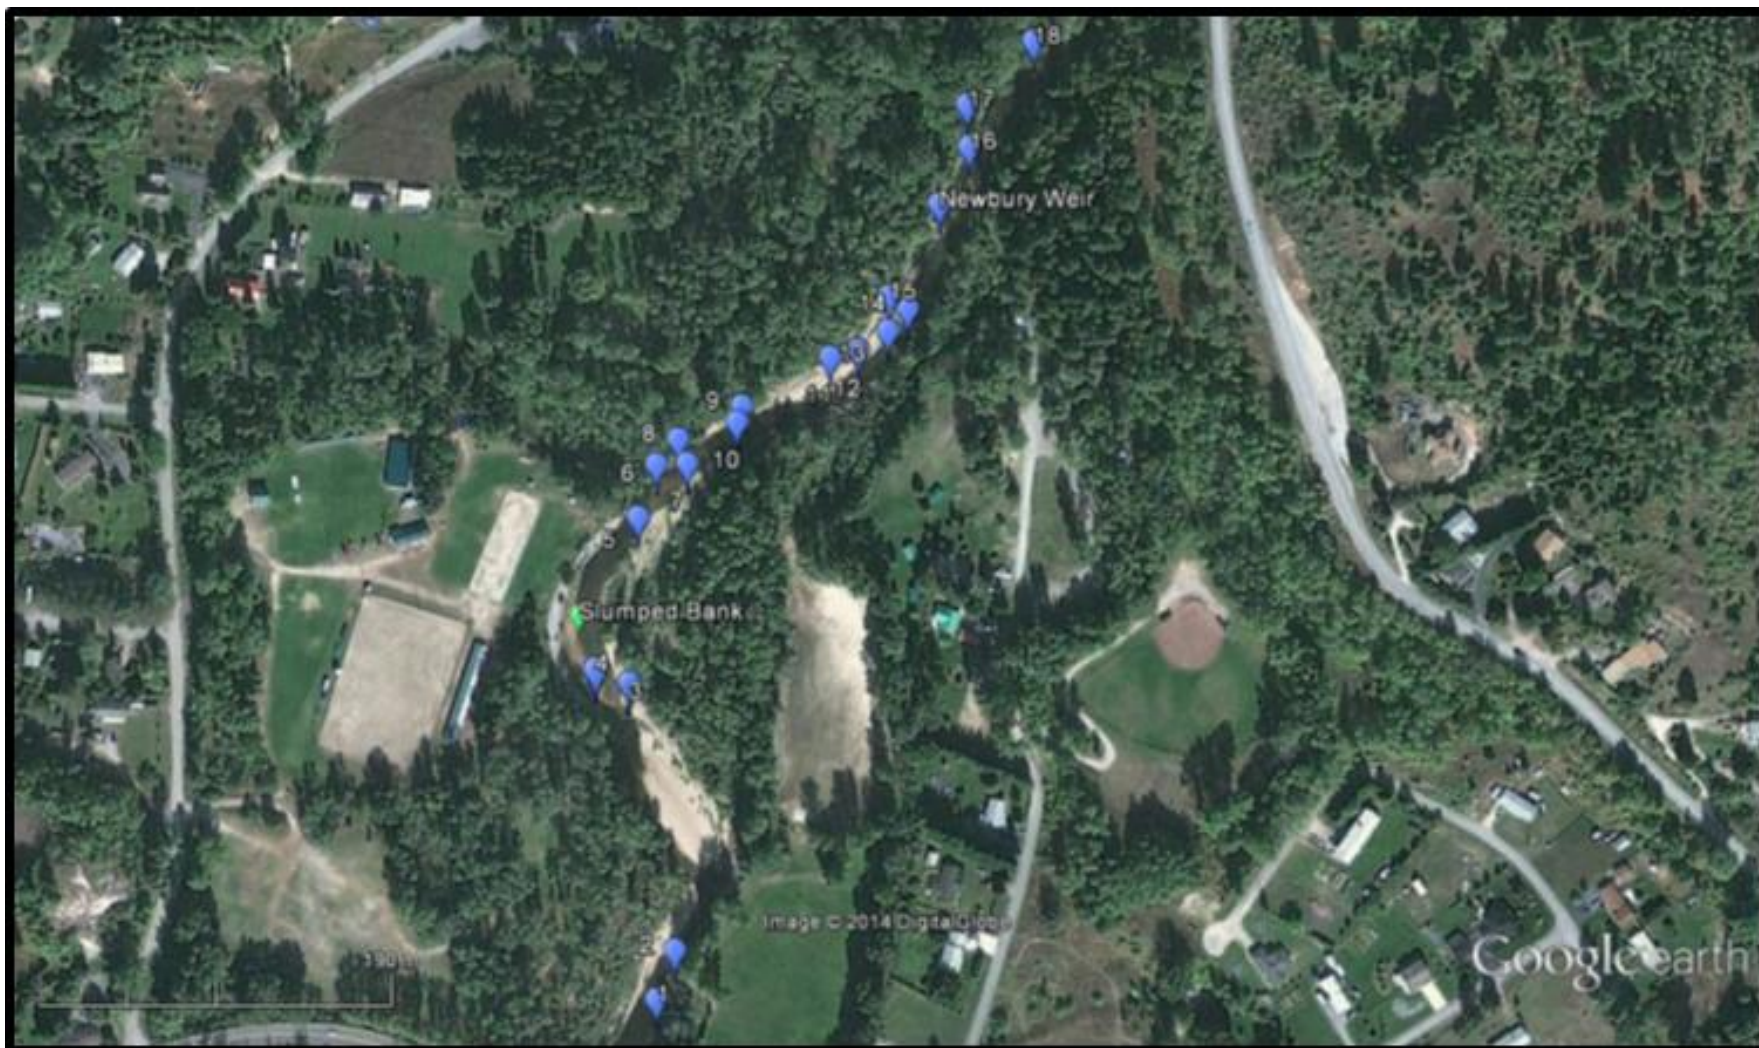
In 2013, Audy and Zimmer (2014) conducted monitoring to assess the condition of the previously implemented habitat structures (Fig. 3). In total, 10 structures required maintenance to reduce public safety concerns (Sites 4, 6, 8, 9, 11, 12, 13, 14, 16, and 17). This would involve removal of cable and nails that may become hazards (Audy and Zimmer 2014).

Figure 3. Habitat structures assessed by Audy and Zimmer (2014) on Pass Creek.

In total, 54 nails and 18 pieces of cable were removed from structures 4, 6, 8, 9, 11, 12, 13, 14, 16 and 17 as recommended by Audy and Zimmer (2014). Structures 8 and 9 were removed from the stream with the excavator and placed on the bank, above the high water mark outside of the stream. A table describing the recommendations and treatment for each structure is provided in Appendix A.

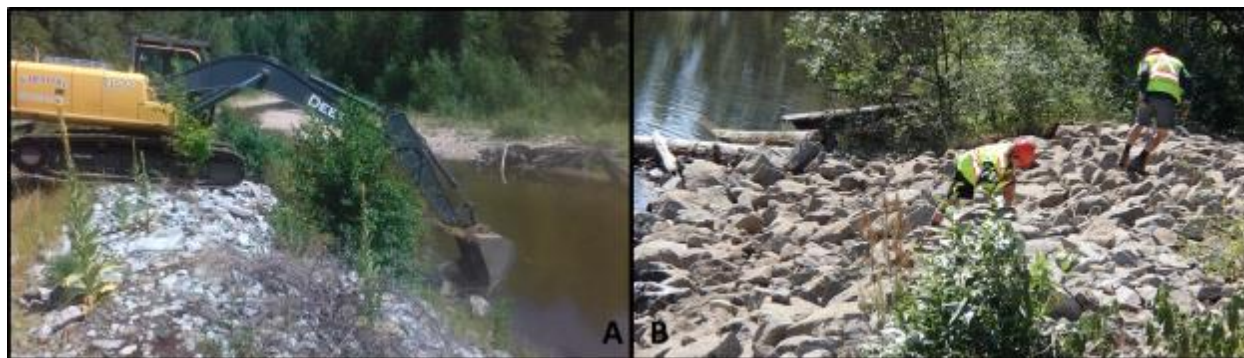
Figure 4. (a) Excavator placing rip-rap on the right bank of Pass Creek at the Pass Creek Regional Exhibition. (b) Regional District of the Central Kootenay employees placing smaller rock in holes to cover all geotextile fabric and spaces in the rip-rap (pictures taken by Evan Smith, Okanagan Nation Alliance, July 2015).

Rocks were placed individually and in small groups by an excavator (Fig. 4a). Smaller rocks (> 0.24 m b-axis) were placed by hand to fill small gaps and ensure the geotextile fabric was completely covered by rock (Fig. 4b). Rocks were placed from bottom to top, and were not dropped from more than 0.3 m to avoid damaging the geotextile fabric. The largest rocks (1 m+ b-axis) were placed at the toe and mid-slope to increase stability. Smaller rocks (0.24 – 0.50 m b-axis) were then placed on top to protect the rest of the slope. Planning rock position prior to placement and individual placement creates a stronger structure more suitable for bank protection. Boulders were supplied and placed by Kabatoff Sand and Gravel Ltd. Rock material was previously approved for metal leaching/acid drainage, making it safe for aquatic use. All work on the rip-rap bank was conducted during the 2015 in-stream work window (July 15 – August 15) and was monitored by a qualified environmental technician.

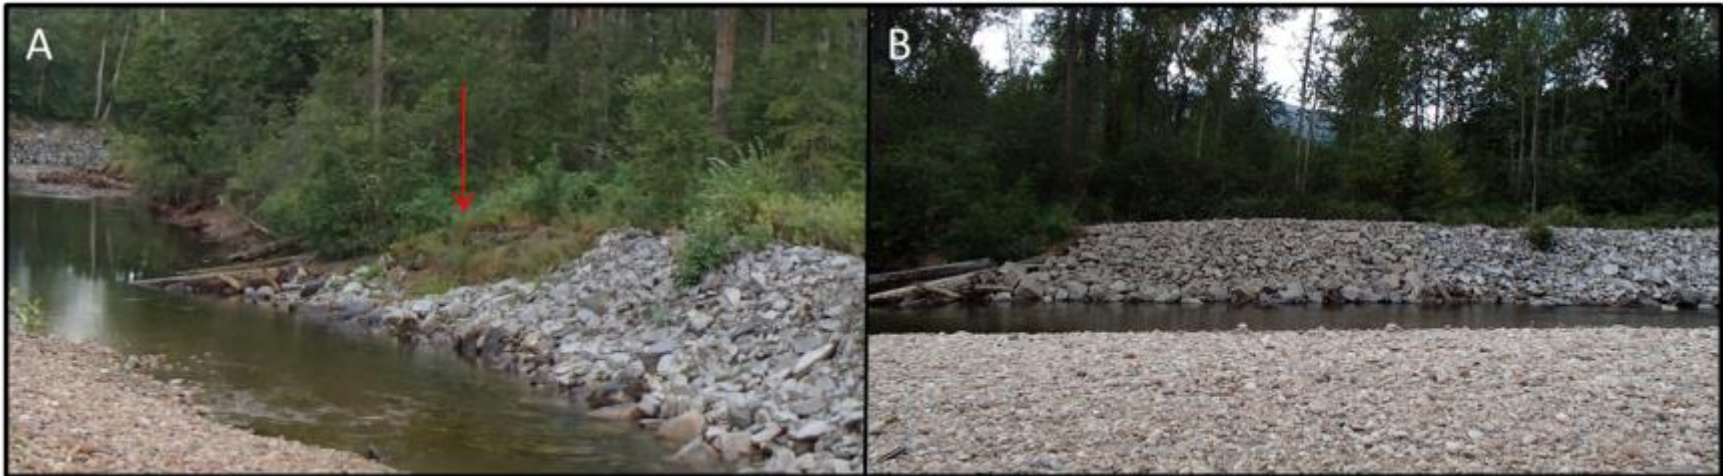
In 2011, the bank of interest was armored with a 1:1 slope of rip rap in an attempt to reduce erosion and undercutting during freshet. However, as a result of the steep slope and improper rock placement, the bank was susceptible to failure during high flows (Norman Deverney, pers comm). As well, the area below the rip-rap bank provided little cover for fish, and this section of stream appeared to have limited in-stream habitat features.

Figure 5. (A) Upstream view of Section 1 (indicated by the red arrow) before repairs were made. (B) View of Section 1 from across the stream after repairs were made pictures taken by Evan Smith, Okanagan Nation Alliance, July 2015).

With guidance and technical instruction from Deverney Engineering, the two failed sections of rip-rap bank were re-contoured from a 1:1 to a more stable 2:1 slope. A ground layer of geotextile fabric was laid beneath the rock to provide support and prevent further erosion of the bank. The ONA contracted Kabatoff Sand and Gravel for the installation of 18 loads of rock to armor the two exposed banks (rock volume $\approx 250 \text{ m}^3$). Small rip-rap material was used to strengthen weakened areas of the bank susceptible to erosion. As a supplementary fish habitat enhancement project, one load (14 m^3) of rock was placed along the toe of the bank in 9 small clusters (<2 m projected length) to provide low-flow fish habitat and deflect the thalweg from the repaired bank at low water levels. This additional work was funded by the Columbia Basin Trust.

In total 18 loads of rock were used to repair the rip-rap bank. The majority of the rock was used to repair the two identified sections (Fig. 5 & 6). Remaining rock was used to strengthen areas of the rip-rap that appeared weakened or susceptible to erosion (Fig. 7). An additional load was placed at the toe of the bank to provide fish habitat and deflect the thalweg at low water levels.

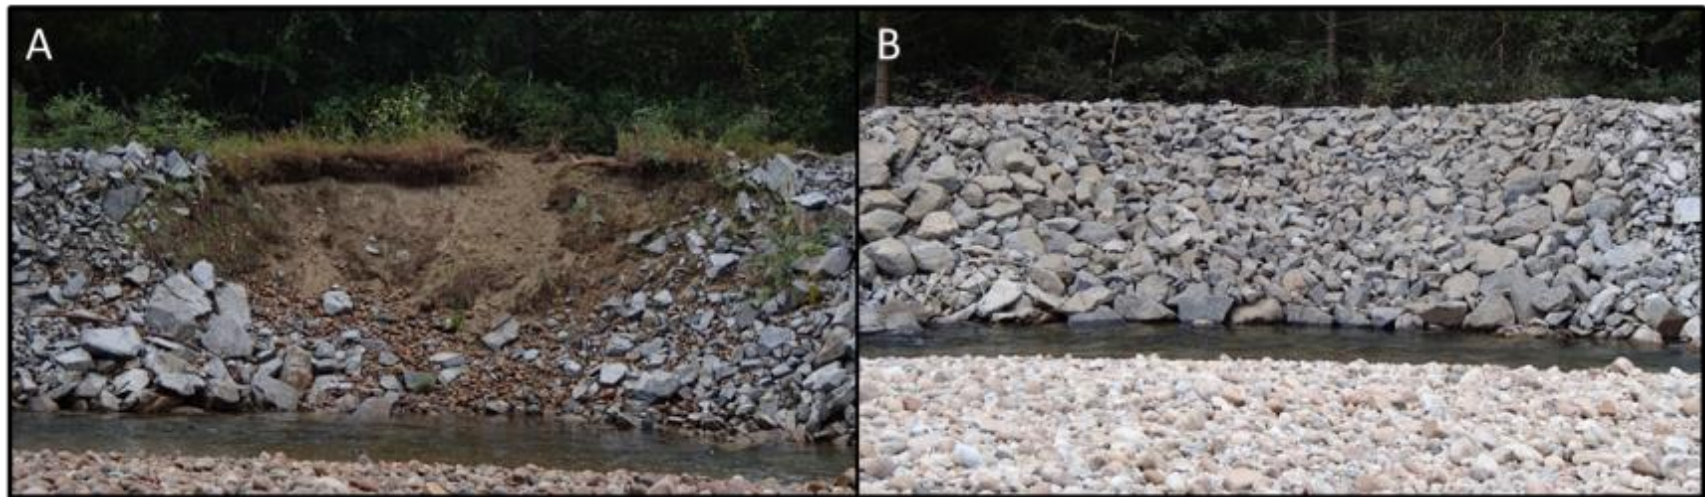
Figure 6. Before (A) and after (B) comparison of Section 2 along the rip-rap bank at pass creek (pictures taken by Evan Smith, Okanagan Nation Alliance, July 2015).

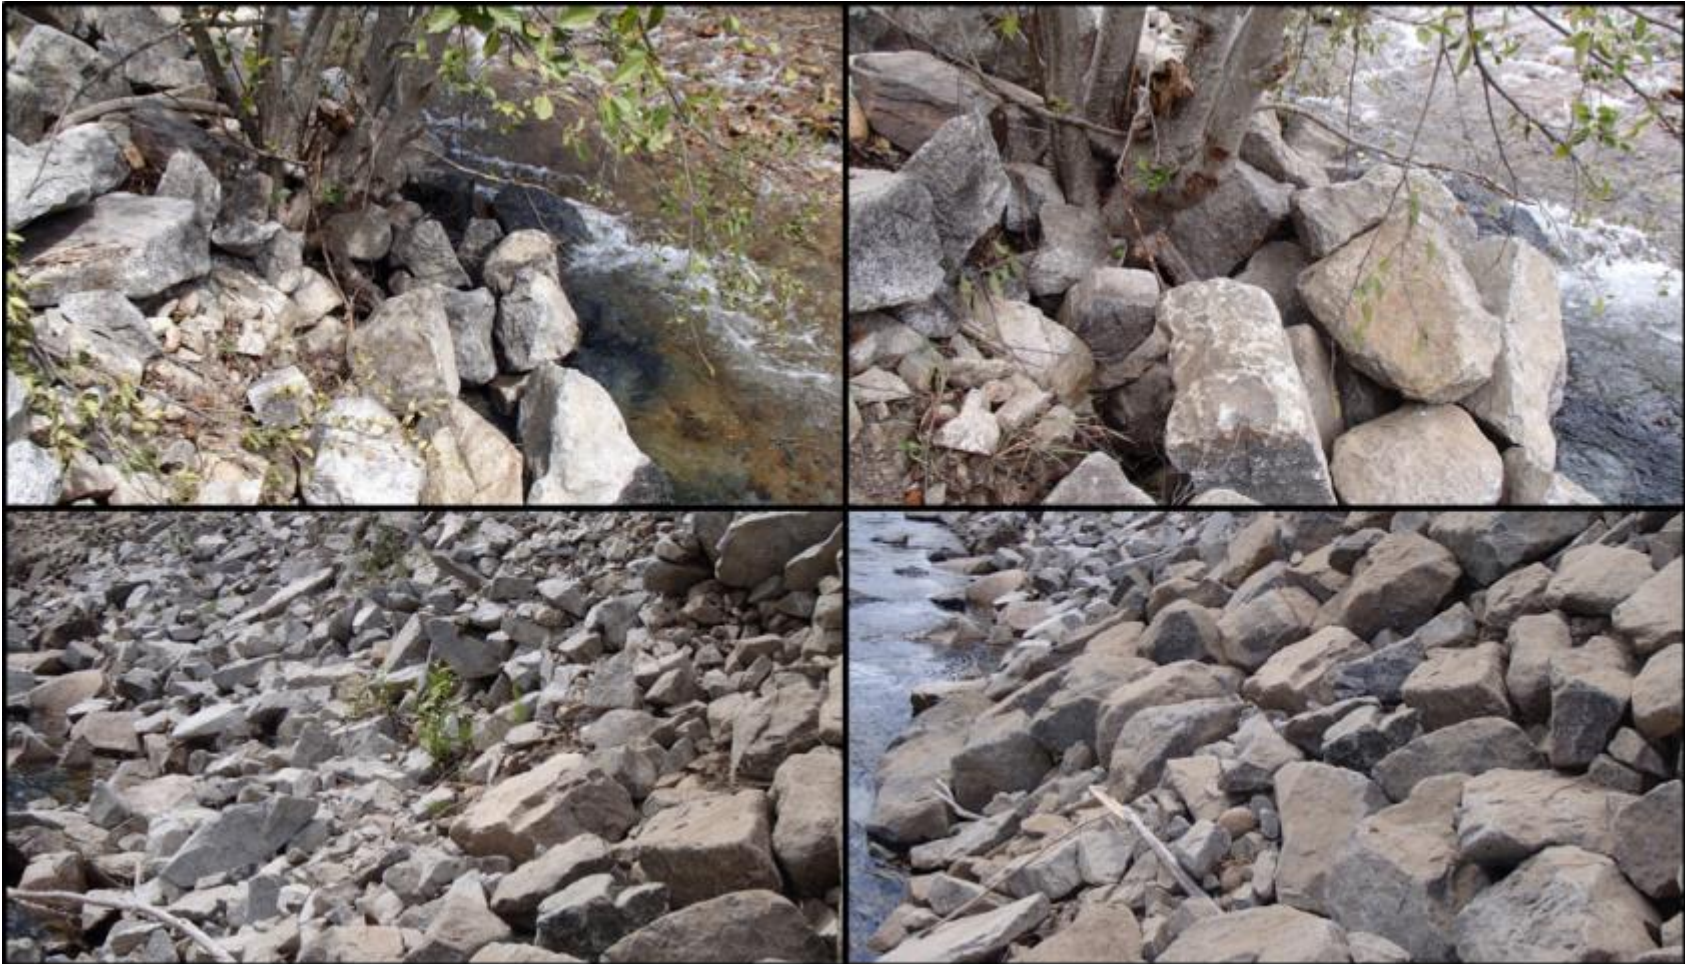
Figure 7. (Top) Before and after comparison of minor bank reinforcement along the toe of the rip-rap bank at Pass Creek. (Bottom) Before and after comparison of target bank stabilization conducted along the rip-bank at Pass Creek. Additional rock was placed at the bottom of this slope to support the top of the rip-rap bank; transforming it from a concaved bank to a 45 degree slope. (all pictures taken by Evan Smith, Okanagan Nation Alliance, July 2015).

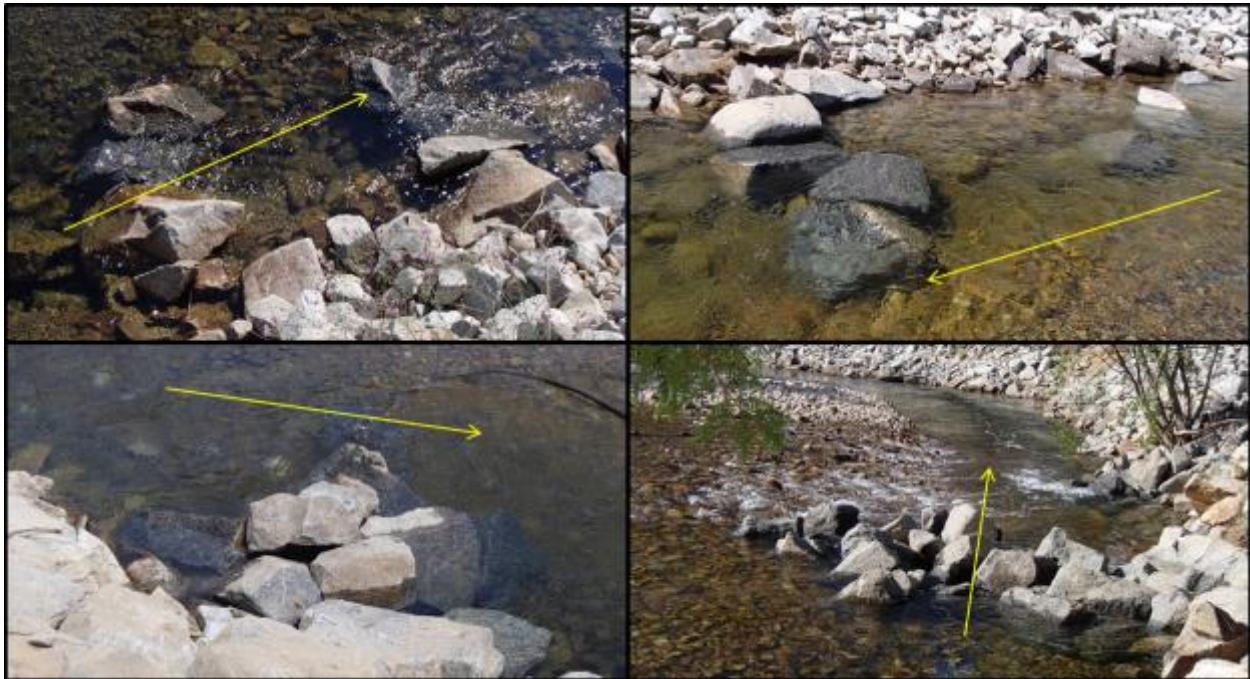
Figure 8. Examples of rock groyne fish habitat structures created to deflect the thalweg at low flows from the rip-rap bank and provide fish habitat at Pass Creek, flow direction indicated with yellow arrow (all pictures taken by Evan Smith, Okanagan Nation Alliance, July 2015).

With additional funding from the Columbia Basin Trust, nine rock cluster structures were created. These structures began upstream of the rip-rap bank of the Pass Creek Exhibition Grounds and continued about 100 m downstream at irregular intervals (Fig. 8). Components of these structures varied from ten to fifteen 0.35 m – 0.60 m b-axis rock to three to five 1 m+ b-axis rock. After construction, the rock clusters appeared to move the low-flow thalweg farther away from the rip-rap bank during low water (pers. obs.).
