**Ellis Creek Sediment Basin fish passage project
2018 ONA FACT SHEET**

PROJECT: Creation of long-term fish friendly access through Ellis Creek's sediment collection basin.

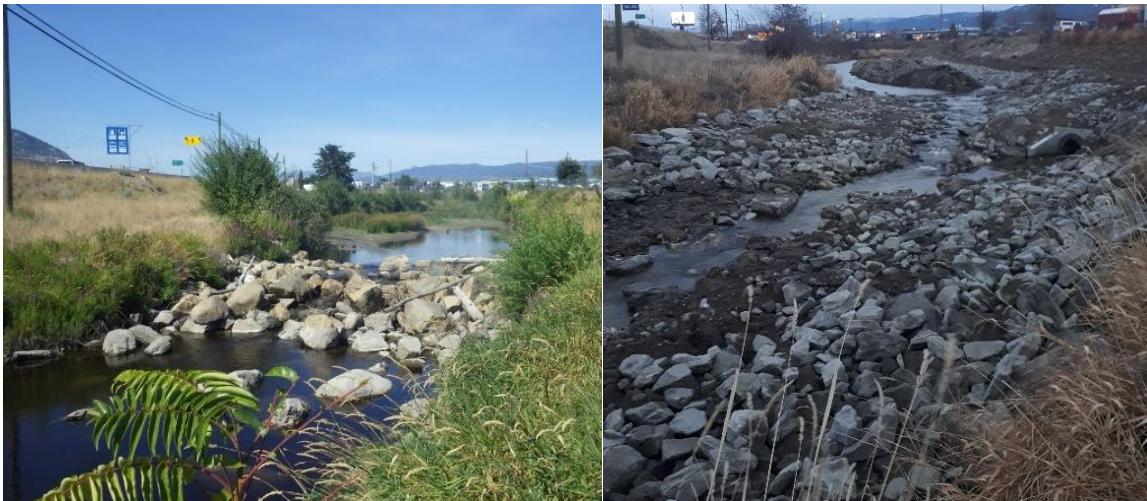
Ellis weir in 2016 (left) and fish passable riffle in 2018 (right)

Ellis Creek sediment catchment basin, located near the creeks mouth is bordered on the downstream end by a rock weir that was constructed to retain transported sediment and prevent it from entering Okanagan River. The rock weir is not passable by fish species year round (Walsh et al., 2006). In addition, the ongoing process of sediment extraction over time negatively affects the local environment and initiates extensive

maintenance requirements. The modifications to the sediment basin have rectified these issues and have opened up 4 km of potential salmon spawning habitat in Ellis Creek (Walsh. Et al., 2006). This project was modeled after a similar project carried out on Shuttleworth Creek's sediment basin in 2015. Construction works are completed; next steps include replanting vegetation in the spring and post-construction monitoring to ensure that restoration is successful.

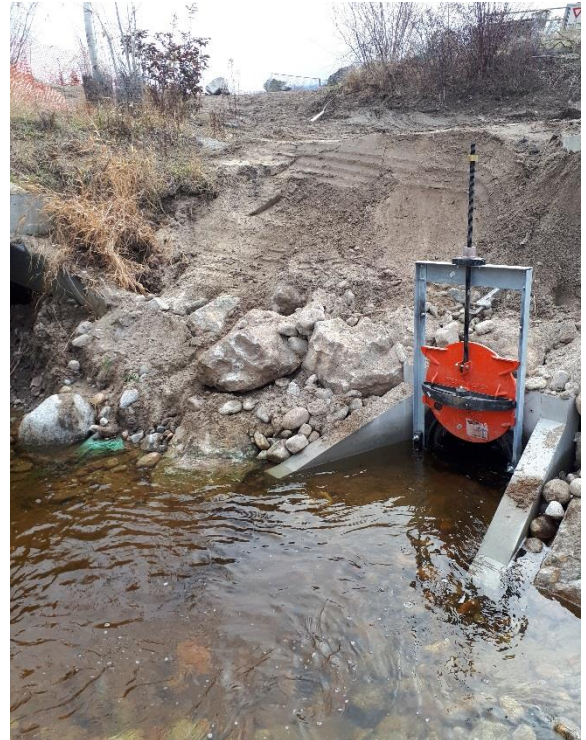
Bypass system inlet

- Riffle was built successfully
- Bypass system is functional
- Many cottonwoods and willows were salvaged before construction and replanted or staked along the bank of the basin
- No wildlife salvage was required
- There were no public safety concerns, despite the popularity of the area for walking
- Banks were graded and left rough and loose in anticipation of planting during the spring of 2019
