# Bessette Creek Bank Restoration

## Restoration works

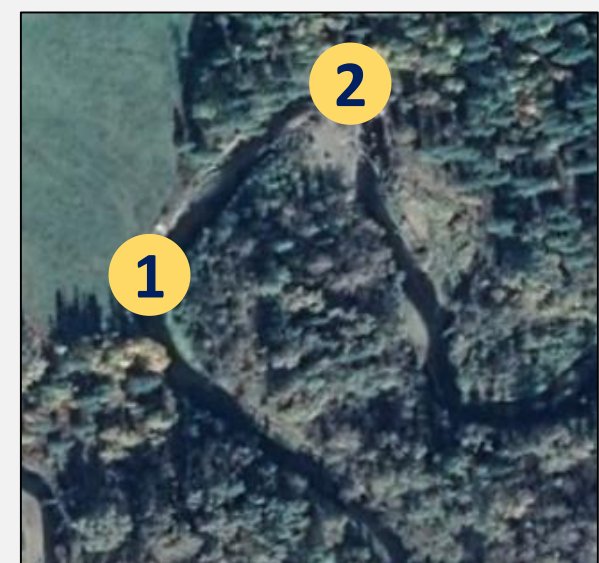
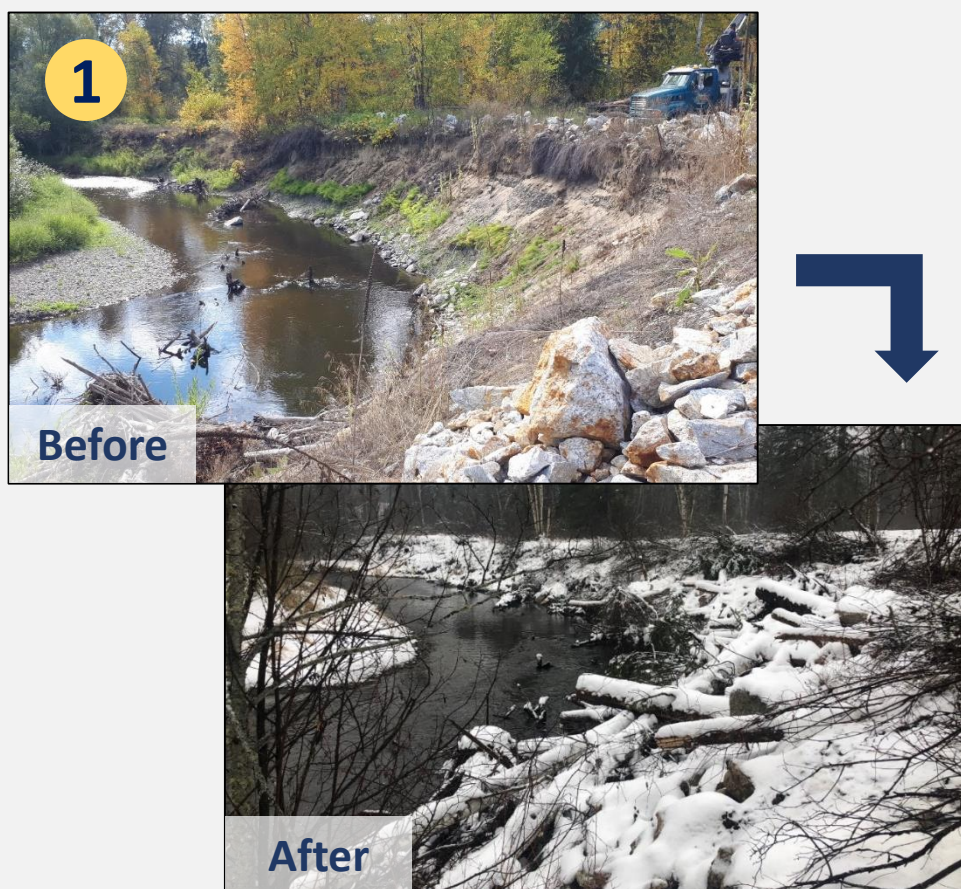
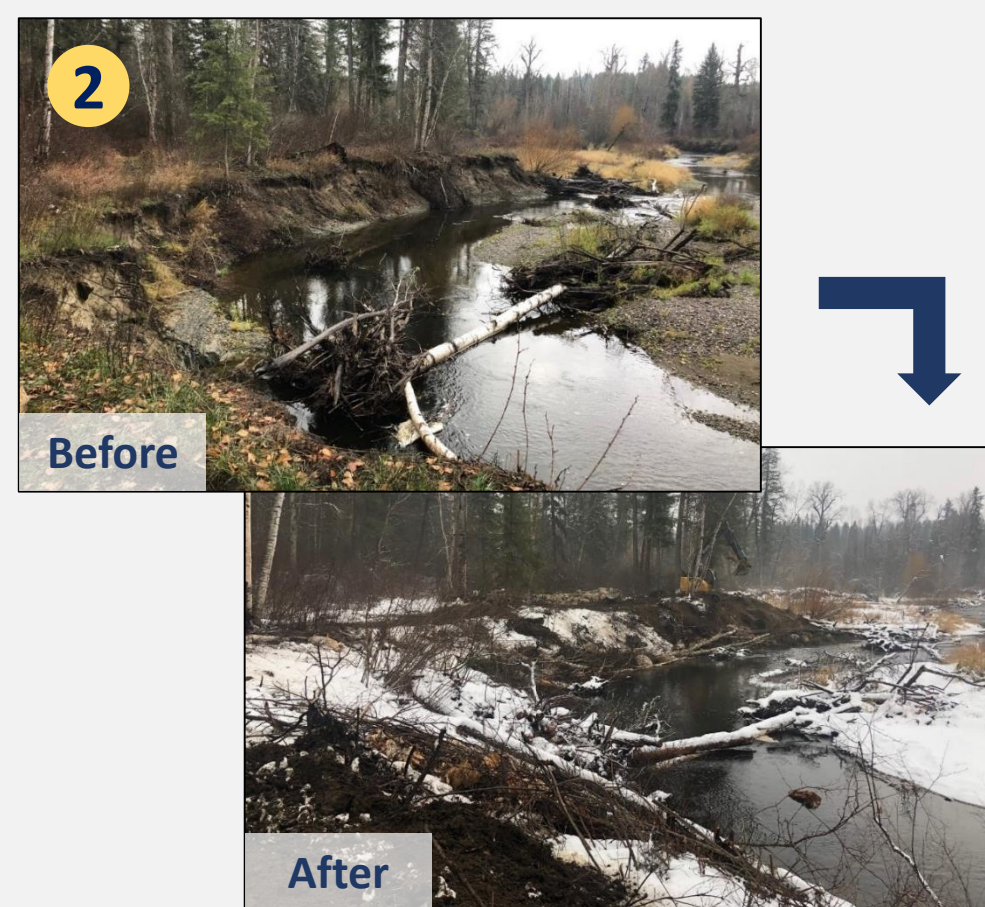
Bank restoration was conducted in November 2021 at two sites where large, exposed banks exist. Large woody debris and boulder structures were installed into the banks to provide protection as well as cover habitat for fish. Tops of banks were re-sloped to a more natural grade to allow greater dissipation of flow energy and promotion of vegetation growth.
