Rip-Rap Repair, Structure Maintenance, and Creation of Fish Habitat in Pass (Norns) Creek 2015 - 2016

FWCP # F-F16-25 & F-F15-25

March 2016

Evan Smith, BSc
Okanagan Nation Alliance
L2 - 1444 Columbia Ave.
Castlegar, BC, V1N 3K3

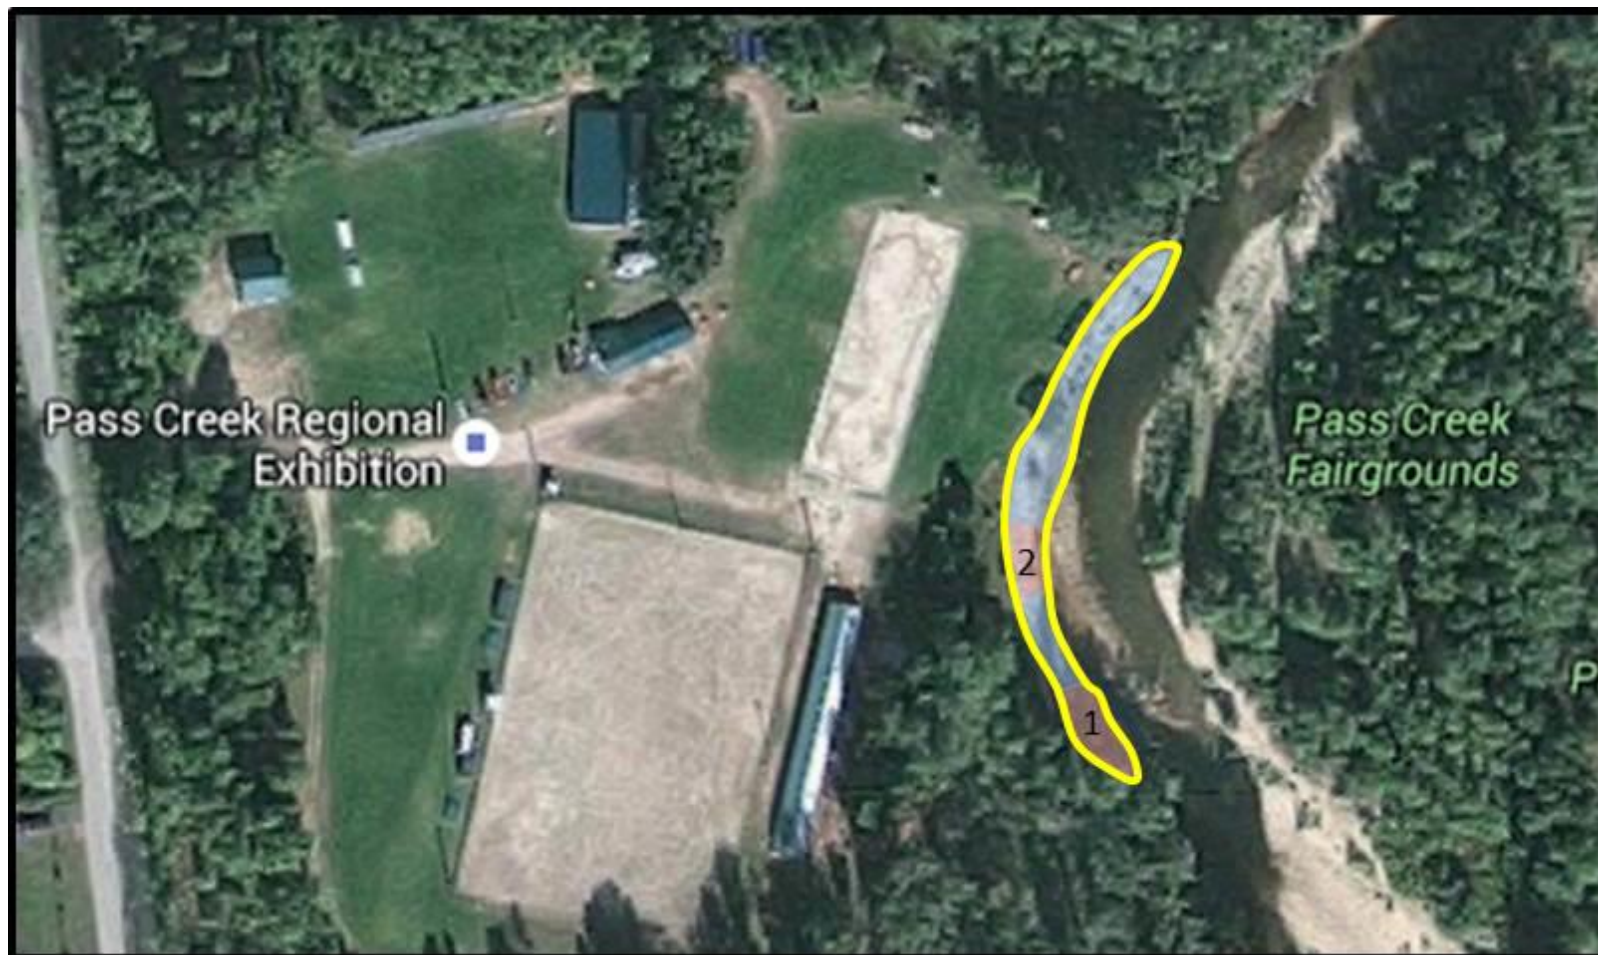
The study area is an approximately 150 m segment of streambank located on the downstream north side of Pass Creek bordering the Pass Creek Regional Exhibition Grounds (Fig. 2). Rip-rap repair focused on two areas (Section 1 and Section 2) each approximately 11 m and 12 m in width, respectively.

In 2011, the bank of interest was armored with a 1:1 slope of rip rap in an attempt to reduce erosion and undercutting during freshet. However, as a result of the steep slope and improper rock placement, the bank was susceptible to failure during high flows (Norman Deverney, pers comm). As well, the area below the rip-rap bank provided little cover for fish, and this section of stream appeared to have limited in-stream habitat features.

Figure 2. Rip-rap and habitat enhancement site (in yellow), and focus areas Section 1 and 2 (in red) on the right bank of Pass Creek, bordering the Pass Creek Regional Exhibition Grounds (Source: Google Maps 2016).

With guidance and technical instruction from Deverney Engineering, the two failed sections of rip-rap bank were re-contoured from a 1:1 to a more stable 2:1 slope. A ground layer of geotextile fabric was laid beneath the rock to provide support and prevent further erosion of the bank. The ONA contracted Kabatoff Sand and Gravel for the installation of 18 loads of rock to armor the two exposed banks (rock volume $\approx 250 \text{ m}^3$). Small rip-rap material was used to strengthen weakened areas of the bank susceptible to erosion. As a supplementary fish habitat enhancement project, one load (14 m^3) of rock was placed along the toe of the bank in 9 small clusters (<2 m projected length) to provide low-flow fish habitat and deflect the thalweg from the repaired bank at low water levels. This additional work was funded by the Columbia Basin Trust.

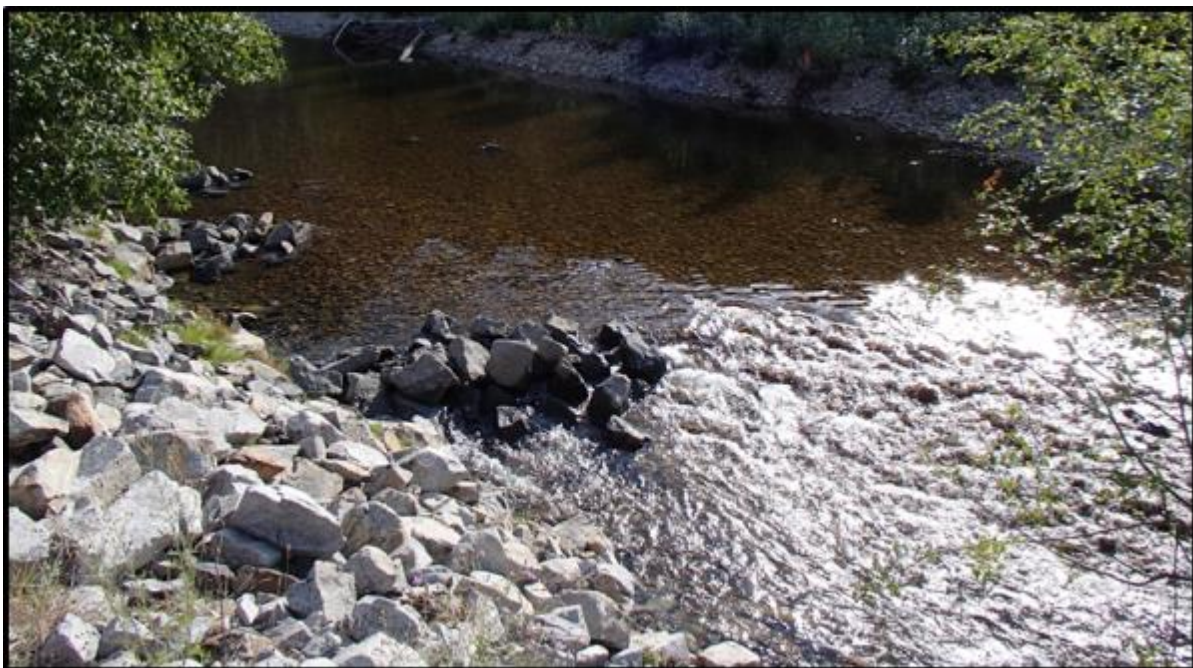
Figure 9. Rock structures created along the rip-rap bank in the Pass Creek Regional Exhibition Grounds creating pools and cover for rainbow fry (picture taken by Evan Smith, Okanagan Nation Alliance, July 2015).

In total 18 loads of rock were used to repair the rip-rap bank. The majority of the rock was used to repair the two identified sections (Fig. 5 & 6). Remaining rock was used to strengthen areas of the rip-rap that appeared weakened or susceptible to erosion (Fig. 7). An additional load was placed at the toe of the bank to provide fish habitat and deflect the thalweg at low water levels.

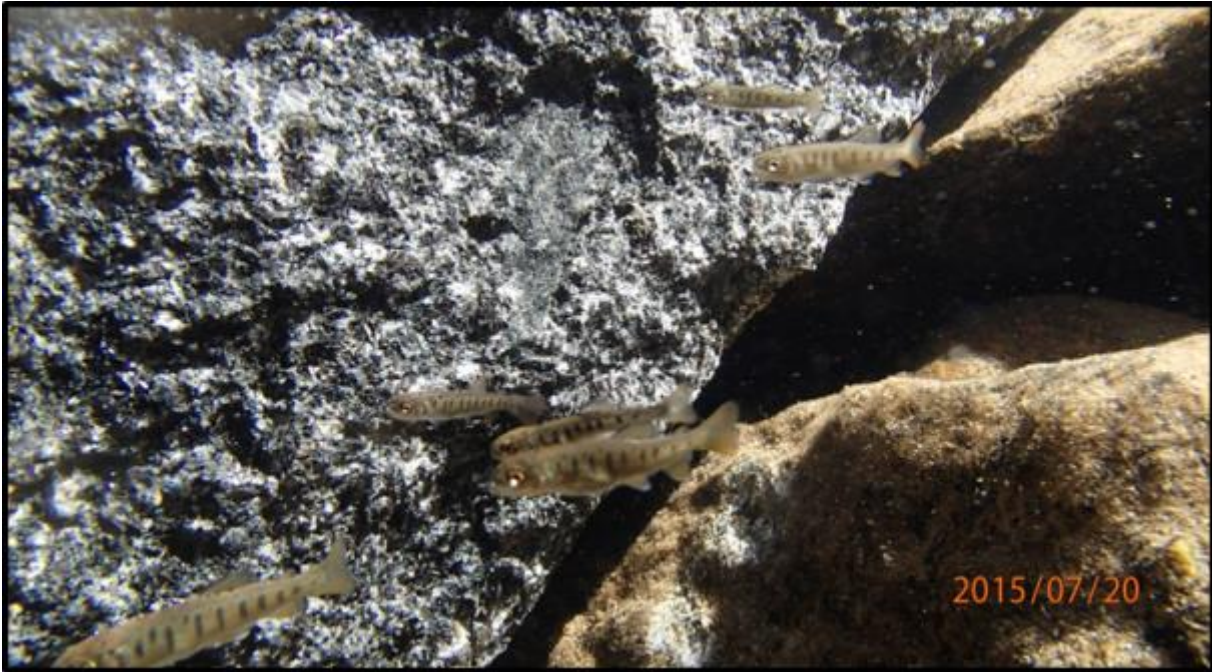
The removal of exposed nails and broken/loose cable has improved safety in Pass Creek for recreationalists. With the volunteer help of the Castlegar and District Wildlife Association hazards were removed quickly and efficiently. Monitoring of these failed structures should take place following high-flow events to identify exposed hazards. The in-stream rock clusters increased interstitial spaces and habitat complexity. These features allow Rainbow Trout fry to escape predators, while the resulting pools downstream of the structures provide fish with resting areas (Fig. 9). After installation, Rainbow Trout fry were observed using the new rock clusters (Fig. 10). These structures have already begun to provide habitat for Rainbow Trout fry.

Figure 10. Rainbow Trout fry using a recently constructed fish habitat structure in the Pass Creek Fairgrounds on the right bank of Pass Creek (picture taken by Evan Smith, Okanagan Nation Alliance, July 2015).
